**Tree Consultants & Contractors**  
**Tel (03) 9888 5214**

31 May 2017

**Re: Stage 8, Kew Cottages**

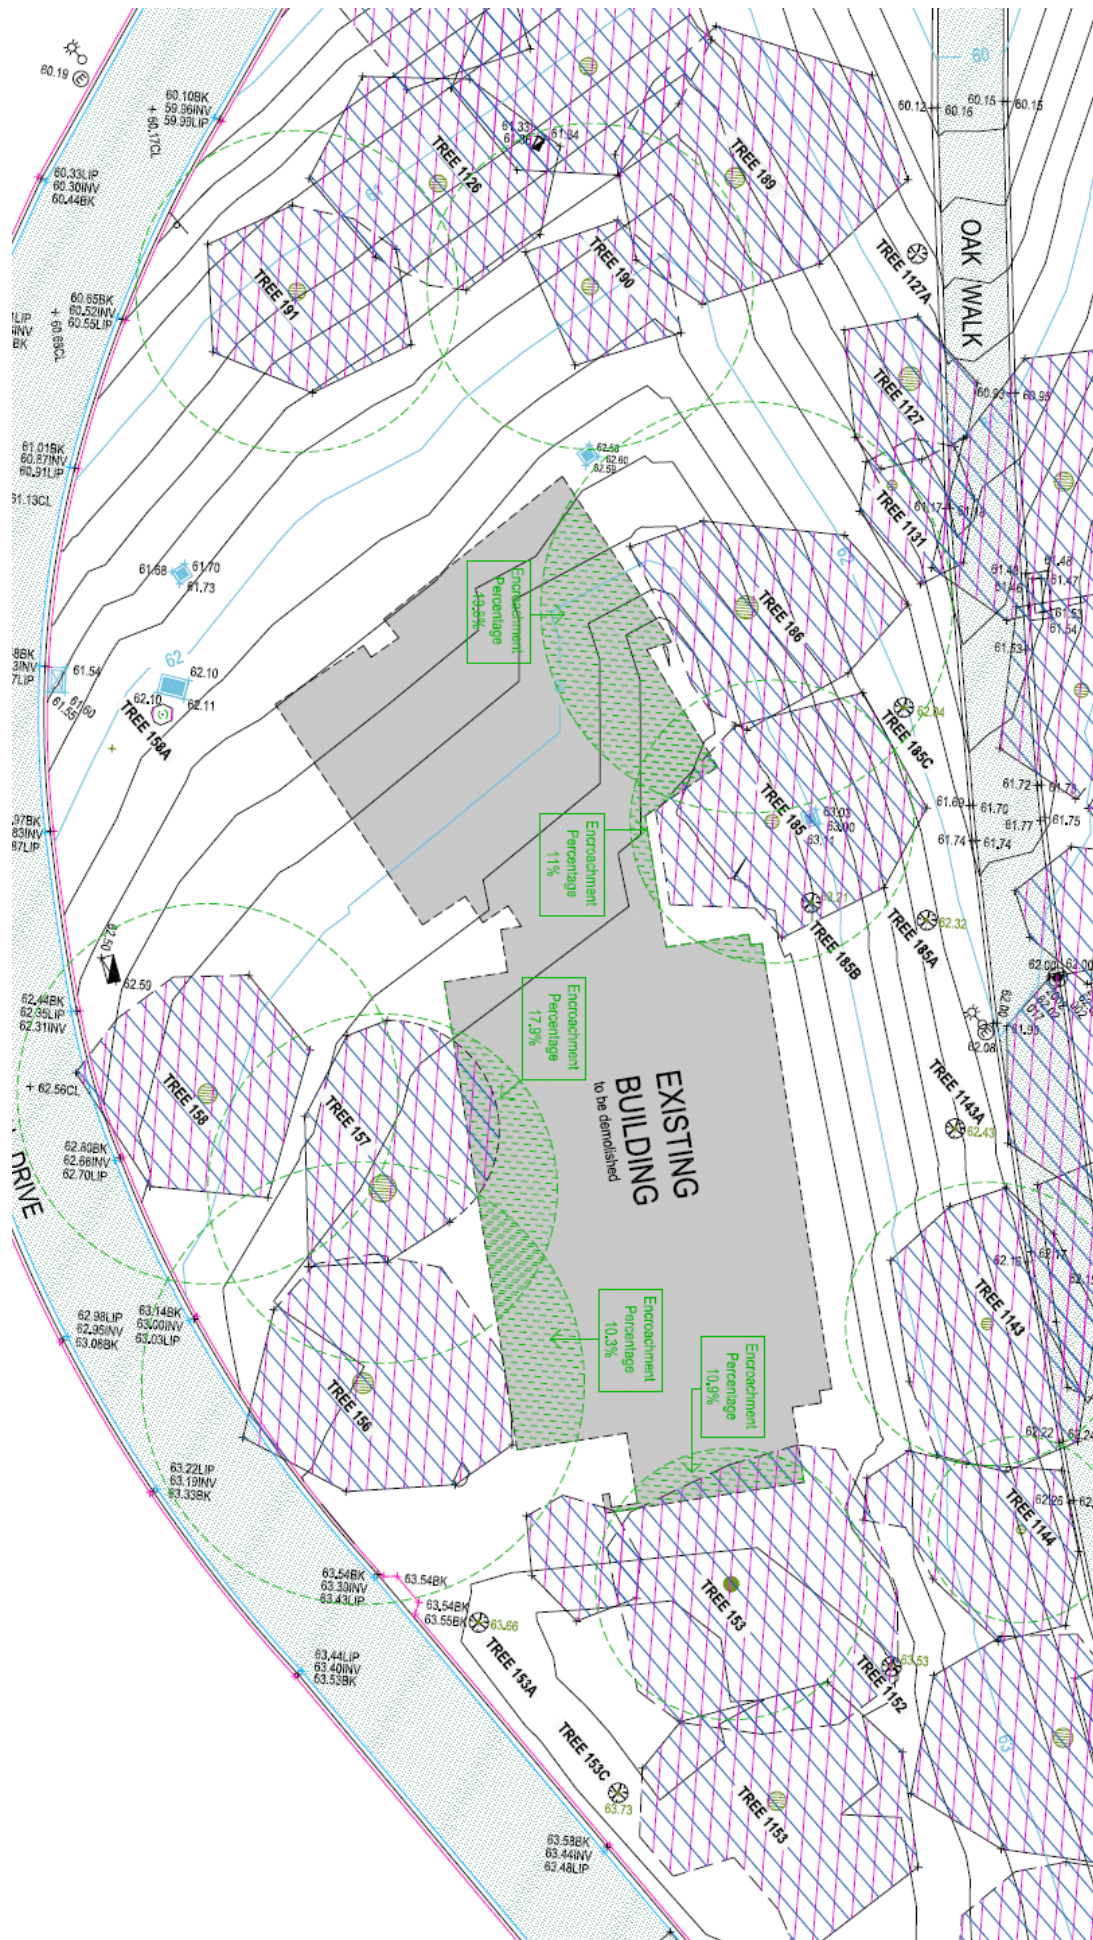
Each tree within the vicinity of the proposal is located and numbered on the accompanying extract of the existing Conditions TPZ Encroachment – Site Plan on page 3 and described in the accompanying table of data on pages 4 and 5. The plan has the canopy extent of each tree accurately surveyed.
