## Assessment of a Canary Island Pine at Kew Cottages

# Health and Condition

**Prepared For:** City of Boroondara  
Darren Bowtell  
8 Inglesby Road,  
Camberwell Victoria  
3124

**1 April 2020**

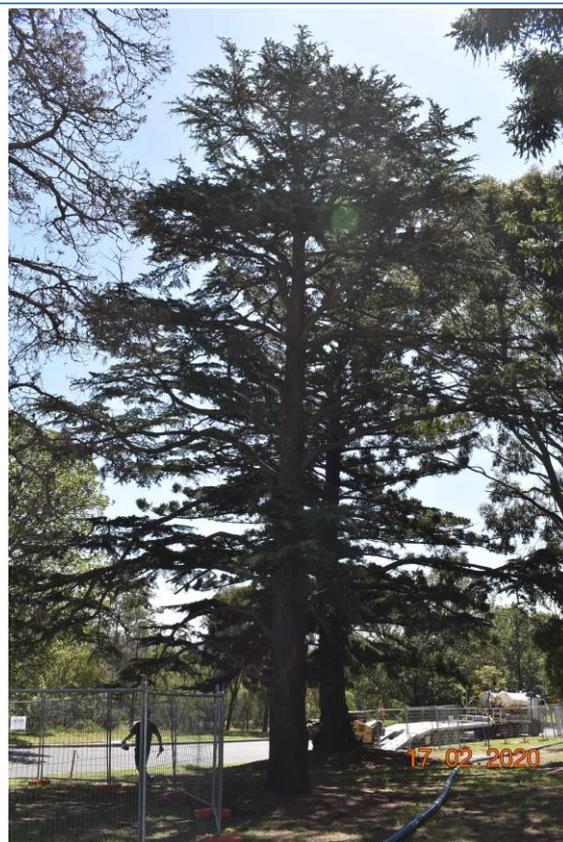
<b>Tree Number</b>	3
<b>Botanic Name</b>	<i>Cedrus atlantica</i>
<b>Common Name</b>	Atlantic Cedar
<b>Origin</b>	Exotic
<b>Tree dimensions</b>	17m x 13m
<b>DBH/DAB</b>	71cm / 87cm
<b>TPZr/SRZr</b>	8.5m / 3.1m
<b>Health</b>	Fair
<b>Structure</b>	Good
<b>ULE</b>	20+ years
<b>Significance</b>	Significant
<b>Retention Value</b>	High
<b>Comments</b>

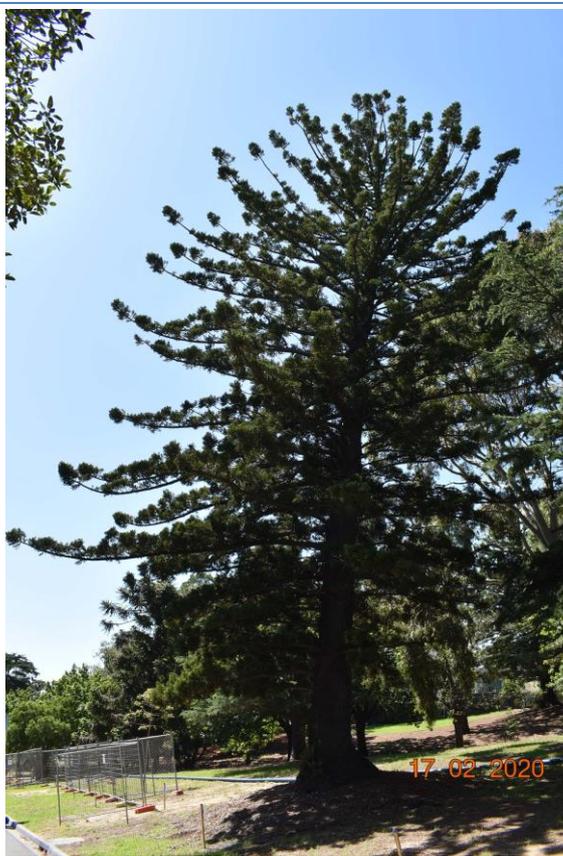
<b>Tree Number</b>	4
<b>Botanic Name</b>	<i>Araucaria cunninghamii</i>
<b>Common Name</b>	Hoop Pine
<b>Origin</b>	Native
<b>Tree dimensions</b>	22m x 12m
<b>DBH/DAB</b>	90cm / 151cm
<b>TPZr/SRZr</b>	10.8m / 3.9m
<b>Health</b>	Good
<b>Structure</b>	Good
<b>ULE</b>	20+ years
<b>Significance</b>	Significant
<b>Retention Value</b>	High
<b>Comments</b>

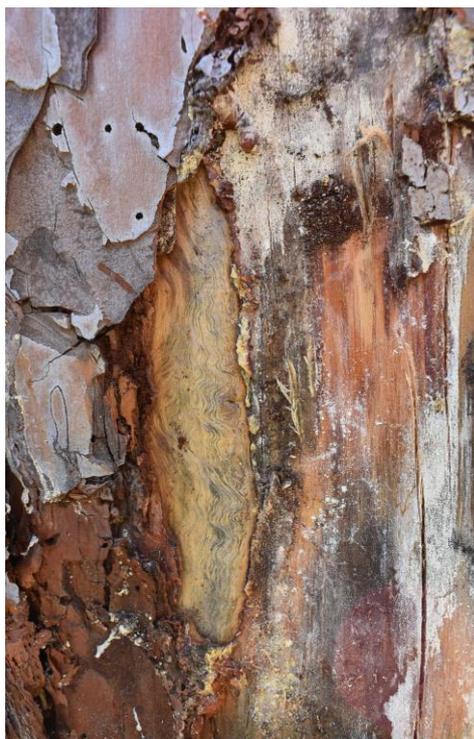
The subject tree died in ~2019 and soils samples were taken for analysis at Crop Health Services, Bundoora to determine if *Phytophthora* had been the cause. At the time of inspection, the tree presented with poor structure, sections of the trunk had decayed. Plates of bark were removed, this revealed that large areas of the cambium had died over several years, with the tree producing wound wood to compartmentalise the decay (Figure 2).

Figure 2: Attempted compartmentalisation of decay

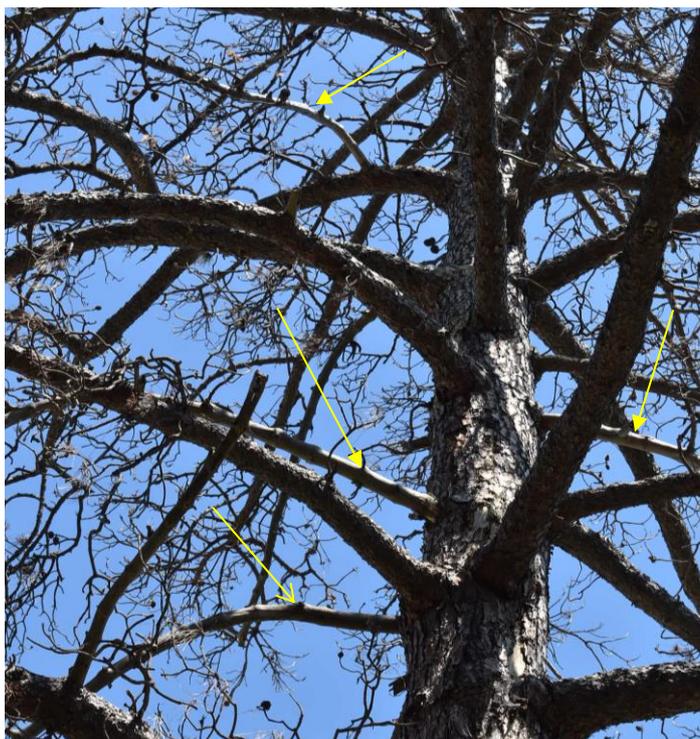
The tree had multiple lesions exuding resin throughout the main trunk. Large pieces of pre-existing deadwood were evident throughout the canopy, suggesting the tree had been in decline for some time (Figure 3). Borers were evident throughout the trunk. No root flare was evident suggesting possible historic grade changes. Adventitious roots were present behind sheets of removed bark (Figure 4).

Figure 3: Large branches within the crown had been dead for some years

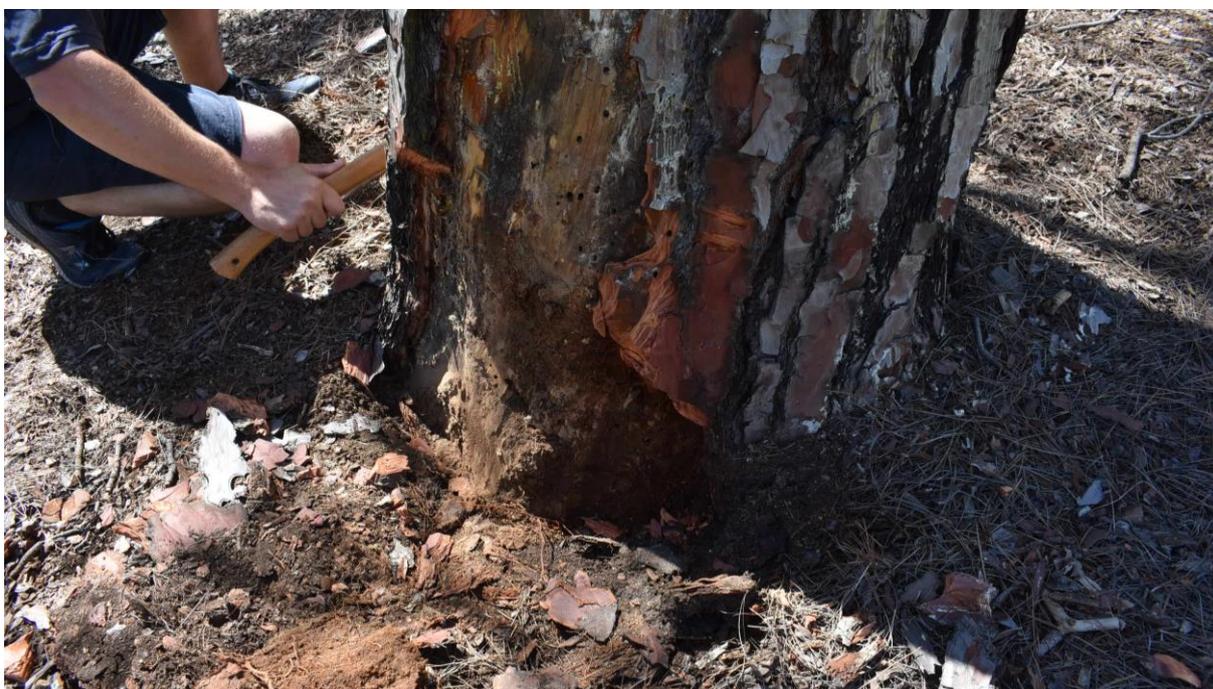
Figure 4: Borer damage & no evident root flare

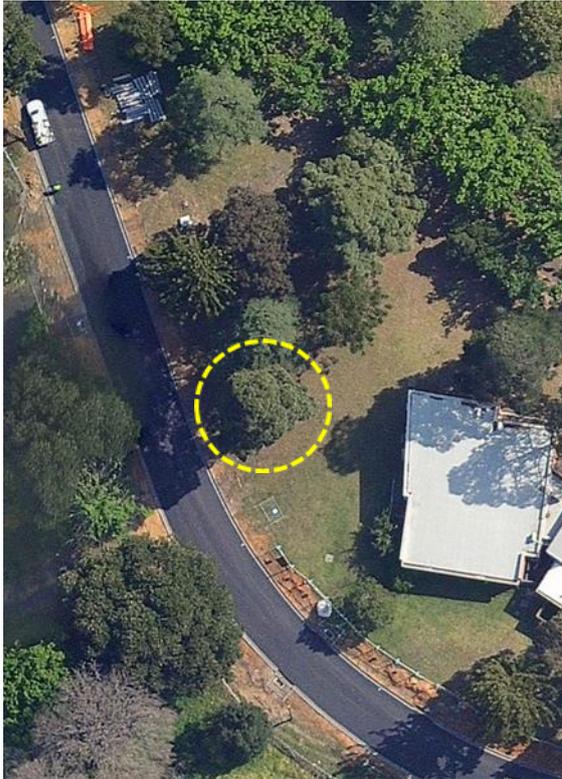
Historic aerial photography shows the decline of the tree over the last 8 years. Extensive drainage works within the subject tree's TPZ took place during October to November 2011. Before and during the works the tree presented in good health (Figure 5). In 2016 the tree presented in fair health showing signs of chlorosis (Figure 6). By February 2019 the tree had lost most of its needles presenting in very poor health (Figure 7), by the end of 2019 the tree was deceased (Figure 8).

Figure 5: Subject tree in Good health - 18/10/11

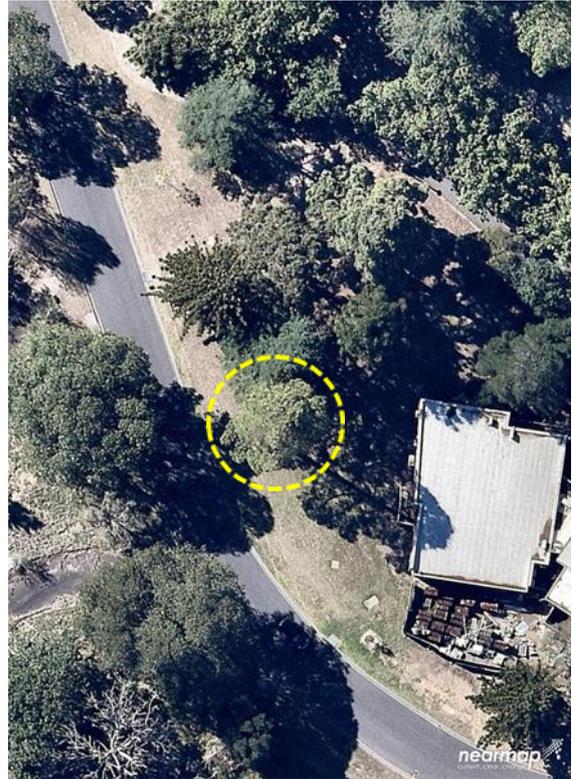
Figure 6: Subject tree in Fair health 20/03/16

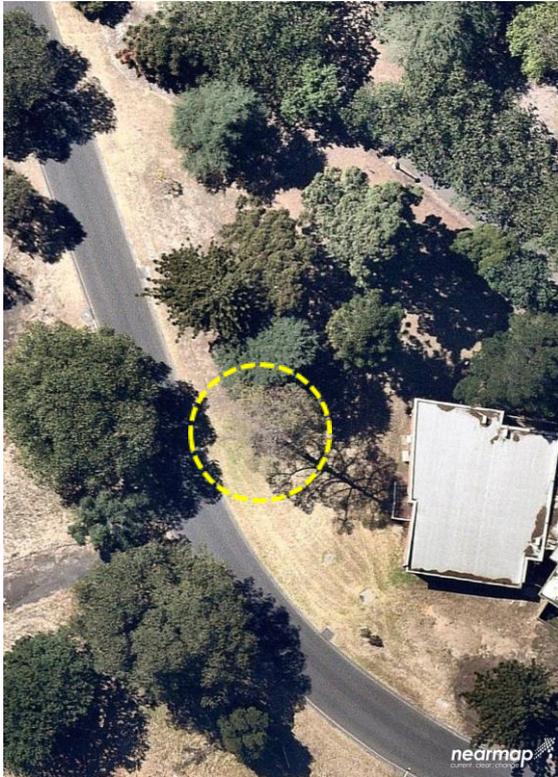
Figure 7: Subject tree in Very Poor health - 23/02/19

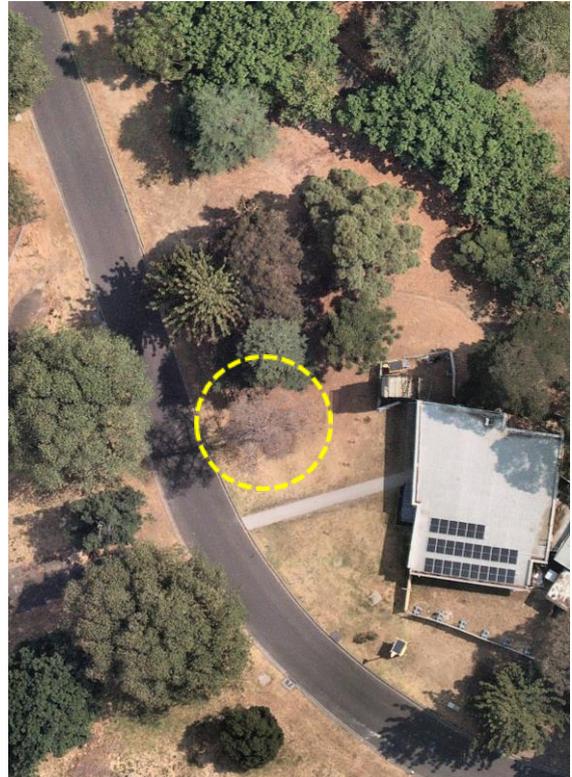
Figure 8: Subject tree Dead - 17/12/19

Historical aerial photography shows the decline of the tree took place over 8 years with the possible catalyst being drainage works within the trees TPZ during 2011 (Figure 8).
