Tree Identification & Retention

SIGNIFICANT TREE SURVEY**SITE:** Kew Residential Services, Princess Street, Kew**DATE:** 15-07-03

PROJECT Kew Residential Services Princess Street, Kew DATE Significant Tree Locations	SCALE 1:1500 @ A1
	DATE July 2005
DESIGNER J. PATRICK	DATE 05/07/05
CLIENT JOHN PATRICK PTY LTD 224 VICTORIA ST MELBOURNE VIC 3121 AUSTRALIA TEL: +61 3 9499 8857 FAX: +61 3 9499 8211 john@johnpatrick.com.au AHS 10 11 12 14 15	JOB No. 05-090
DATE 05/07/05	JOB No. 05-090

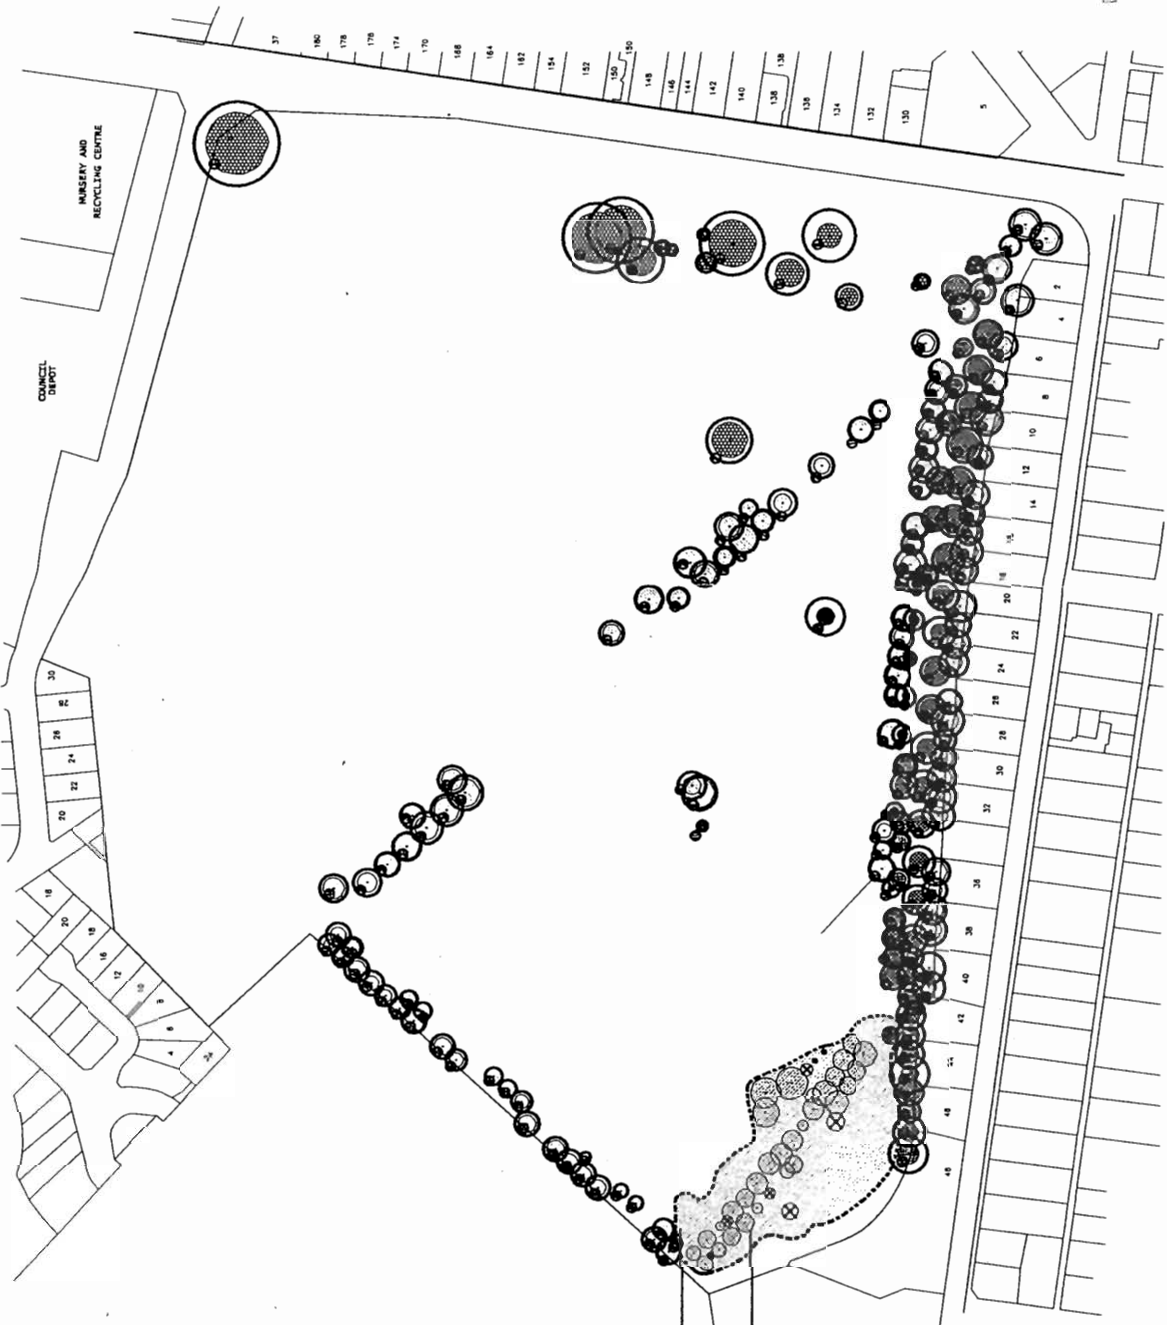
For all trees identified for retention Tree Protection Zones have been prepared following the guidelines prepared by Matheny & Clark in *Trees & Development*. The significant trees are all located on Plan 03-090 together with their proposed Tree Protection Zones. The identification of all significant trees together with an assessment of their health, tree protection zone and required works are provided in Appendix 1.

Area of indigenous
Wattle grass (*Austrodanthonia* sp.)
within south-west plantation

"South-West Platanon" containing
a number of mature, largely coniferous trees
